**Belge:** 20SAB02 NINOY AQUINO INTERNATIONAL AIRPORT (MNL),  
THE PHILIPPINES

20SAB02 21 January 2020 Ninoy Aquino International Airport (MNL), the Philippines

Operations Notice Number: ON 001/2020

**Title:** Ninoy Aquino International Airport (MNL), the Philippines Applicable to: All operators

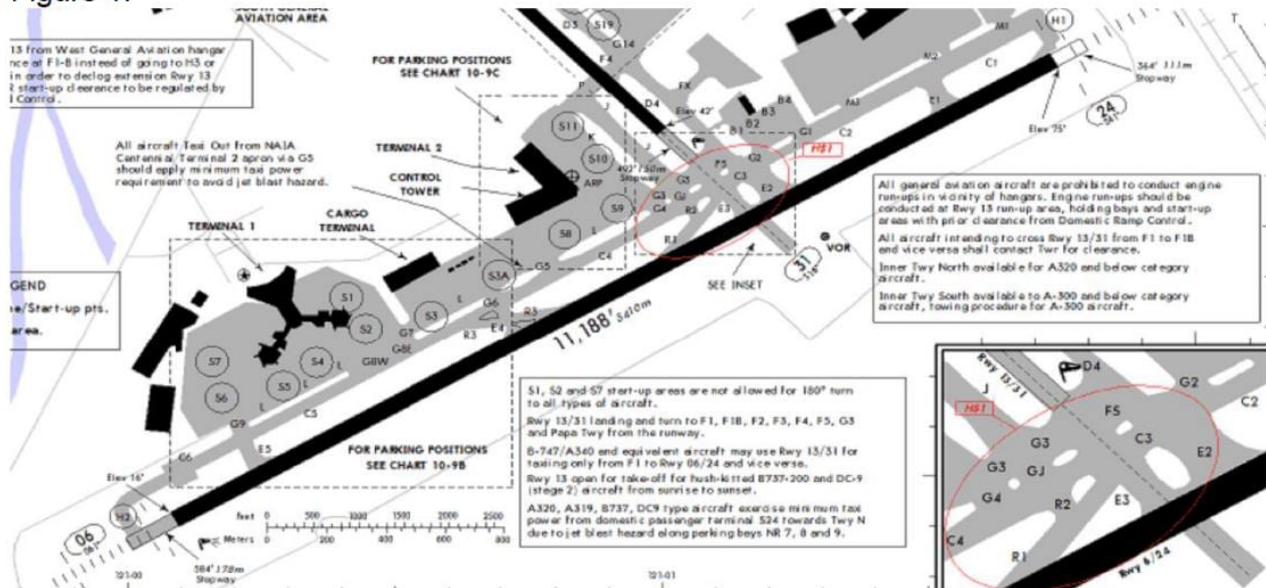
Figure 1:

- The intersection of RWY 31 /13 and RWY 06/ 24. This intersection is a known ‘hot-spot’ area as shown in Figure 1 below. Flight crews have described this hotspot area as:
- Poorly lit
- Markings and signage that are non-standard and poorly maintained
- Confusing due to the complex configuration of taxiways

- Alert flight crews of the existing hazards and potential for runway incursion in the ‘Hot-Spot’ area and apply appropriate operating procedures to mitigate the associated risks
- Airlines are strongly encouraged to continue to report all airside ground deficiencies and related safety events to MIAA via the email addresses below: o To: Raffy Regular, Head for Airport Ground Operations and Safety Department: miaasafety@gmail.com; aod.miaa@gmail.com; rsregular112@yahoo.com o CC: Ed Monreal, General Manager: gmo.miaa@gmail.com Alvin Candelaria: candelariasr.alvin@yahoo.com aerodromesafety@gmail.com o Airlines are also requested to copy IATA (aspacsf@iata.org) when any safety reports are submitted to MNL and/or inform IATA when feedback is not received from MIAA
- This Notice will remain in effect until member airlines have confirmed that all noted hazards have been sufficiently addressed.
